# Manhole Inspection Summary

Manhole # S45UU\_026MH

**Location** Address: **2701 THE ALAMEDA**

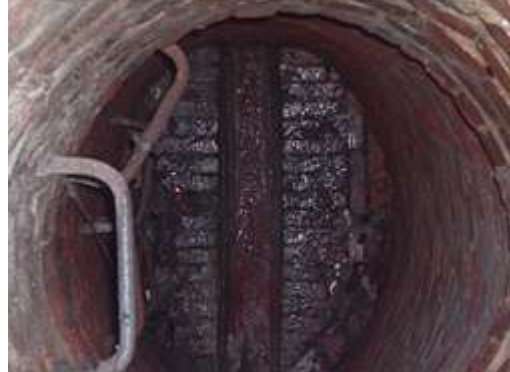
Top View

Infiltration: ☐ None ☐ Joint ☐ Cracks ☐ Mortar ☐ Roots ☒ **Wall**

☐ Parged ☒ **Debris** (not Condition related)

**Steps** Count: **5** Missing: **0** ☒ **Corroded**

**Surcharge** ☒ **Evidence Of Surcharge** Depth: **1.5** (ft.) ☐ Active Surcharge Present

Barrel infiltration. Corroded steps.  
Evidence of surcharge - Bench debris.

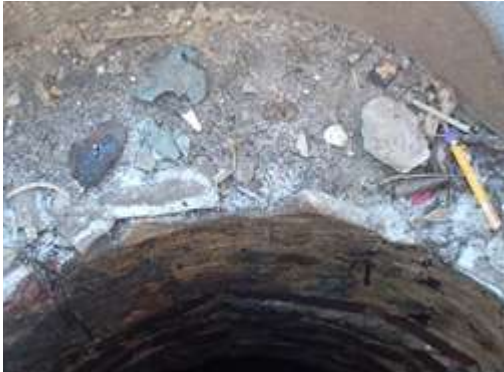
Defect

**Frame** Offset: **6** (in.)

☒ **Leaks**

Condition: ☐ Sound ☐ Cracked ☐ Root Intrusion ☐ Loose Brick ☒ **Deteriorated**

Infiltration: ☐ None ☒ **Joint** ☐ Cracks ☐ Mortar ☐ Roots ☒ **Wall**

Frame leaks. Frame offset. Adjustment  
deterioration and infiltration.

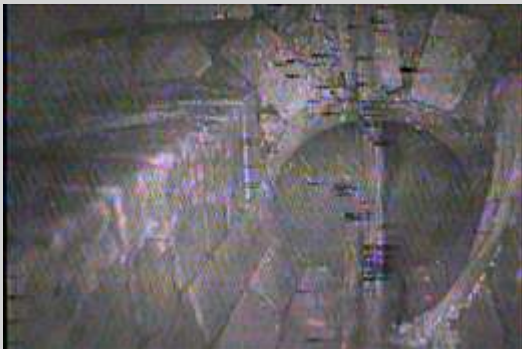
### 8 in. Circular Gravity Sewer Pipe In @ 6 O'Clock

Infiltration: **Evidence** Pipe Seal Cond: **Unknown**

Drop: **Outside** Rod and Bar

Drop Condition: **Clogged**
